**Subject: Application for Consultation and Guidance
Eligibility Criterion for Interim SWPPP Plan
Protoco Landfill Superfund Site
Peñuelas, Puerto Rico**

FLORA AND FAUNA SURVEY FOR LISTED
SPECIES AT THE OLD PROTECO LANDFILL
SITE IN THE AUTONOMOUS MUNICIPALITY
OF PEÑUELAS, PUERTO RICO

FLORA AND FAUNA SURVEY OF LISTED PLANTS, REPTILES, AND BIRDS SPECIES IN THE EXISTING OLD PROTECO LANDFILL SITE LOCATED IN THE AUTONOMOUS MUNICIPALITY OF PEÑUELAS, PUERTO RICO

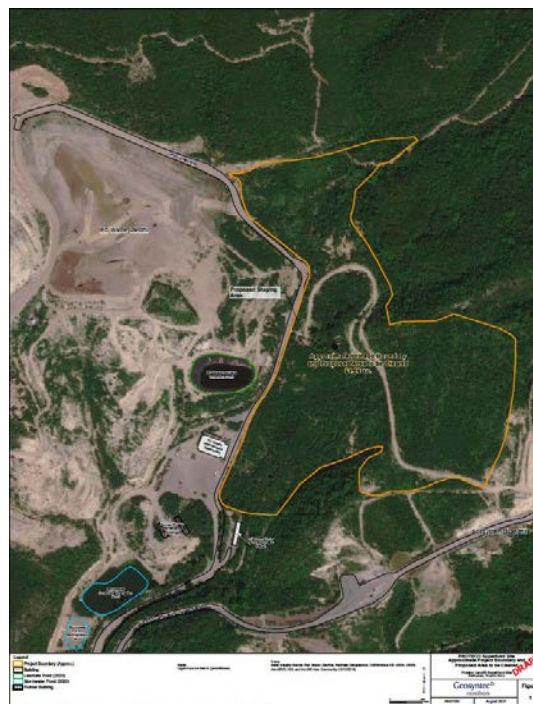
Figure #1 Photo showing the general location of the PROTECO site in Peñuelas, Puerto Rico. The yellow line shows the approximate site boundary.

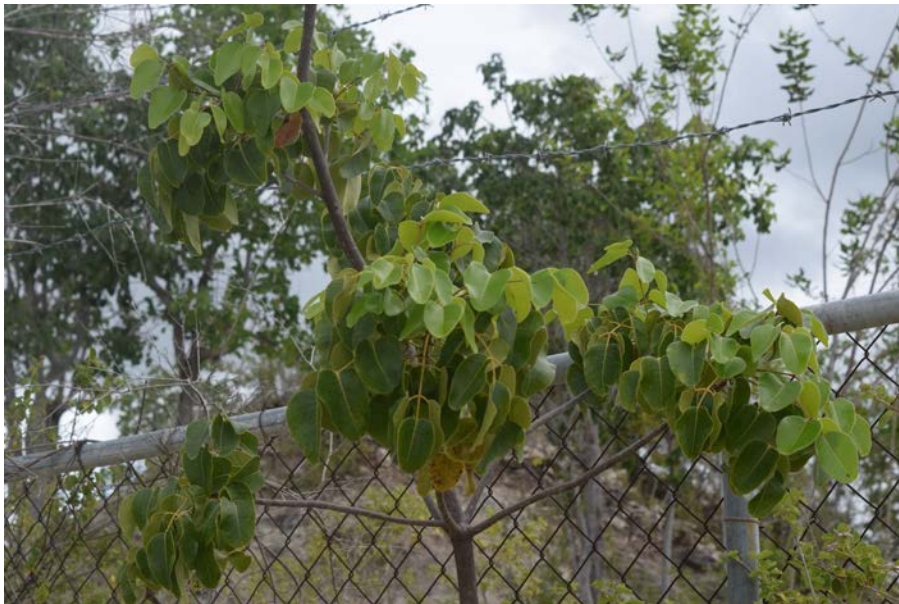
Picture 2 Picture of the tree Arbol de Papayo (*Metopium toxiferum*). Caution. Toxic

Note: There are several species, including bees and toxic trees, on the Site. It is important to consider their existence in the safety plan and while working on the property.

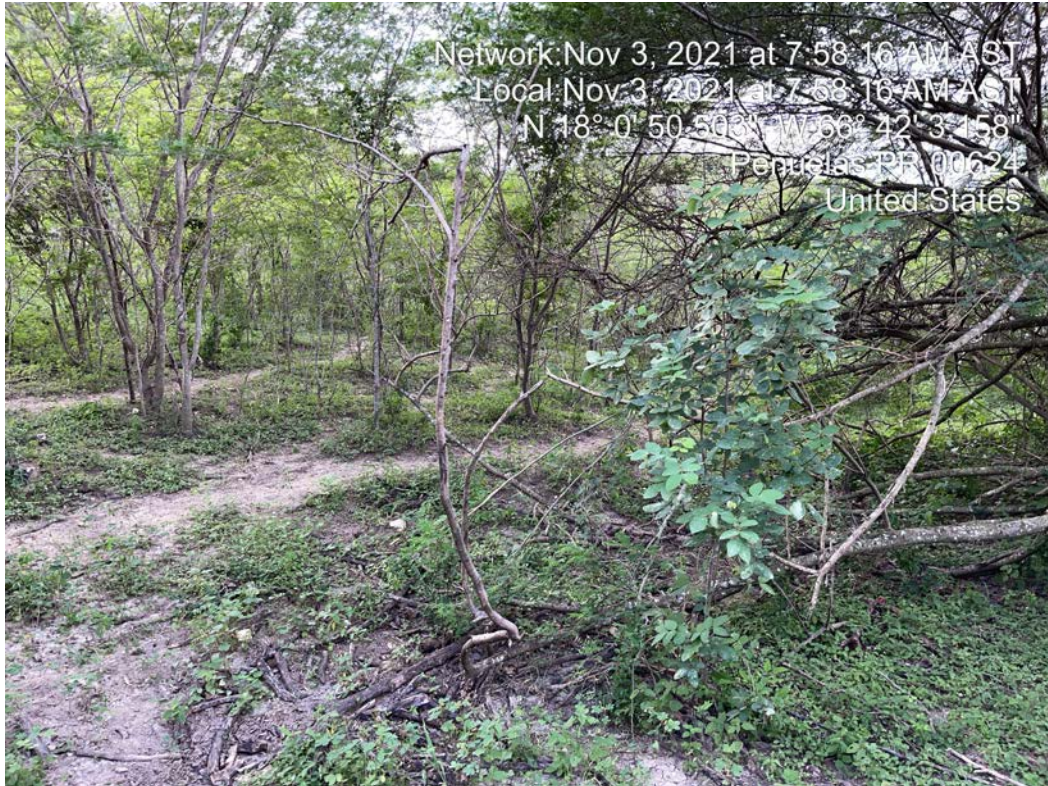
Picture 3 View of the prevalent ground conditions around the property. The ground is covered with trails.

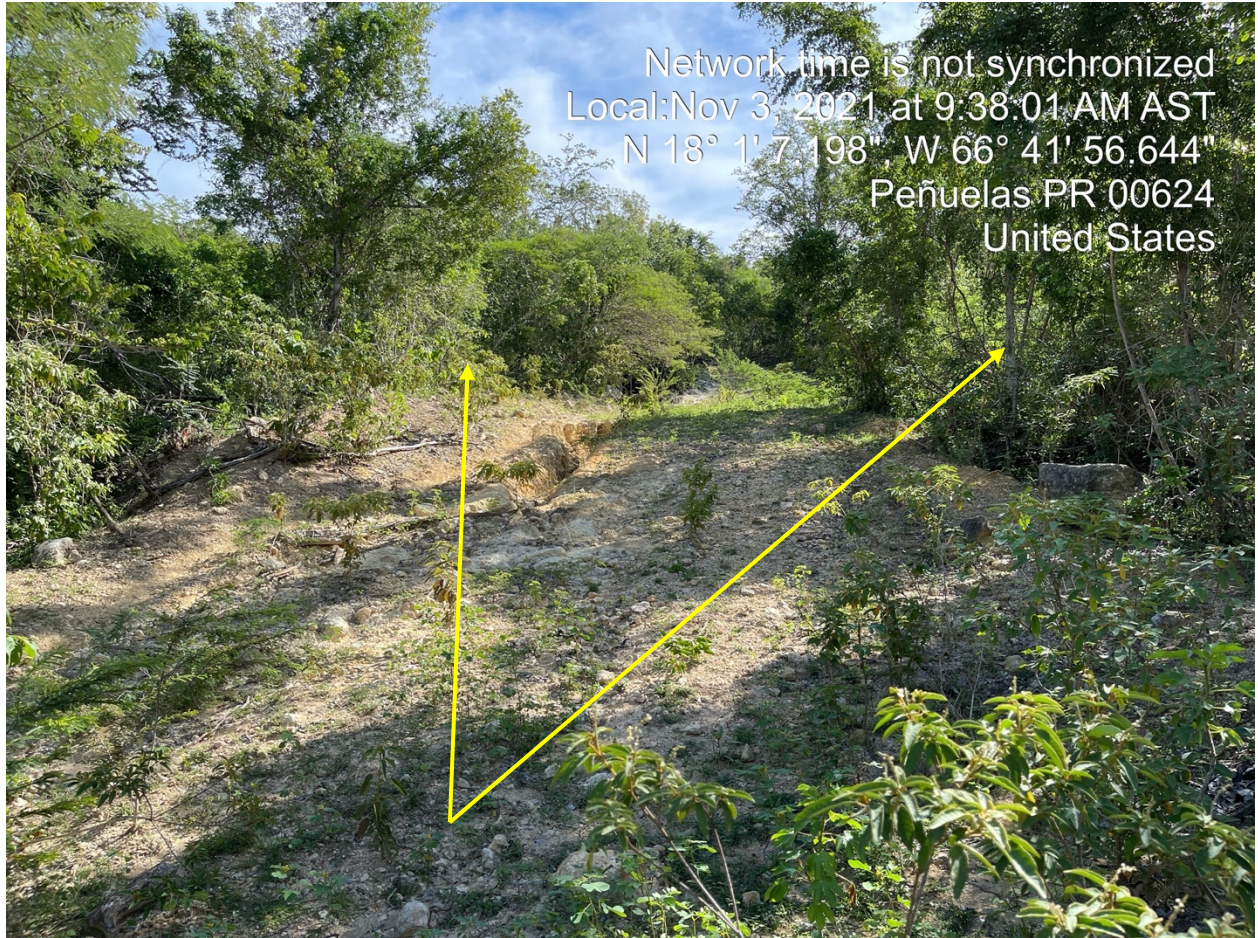
Picture 4 Conditions on both sides of the access roads towards Zone #14.

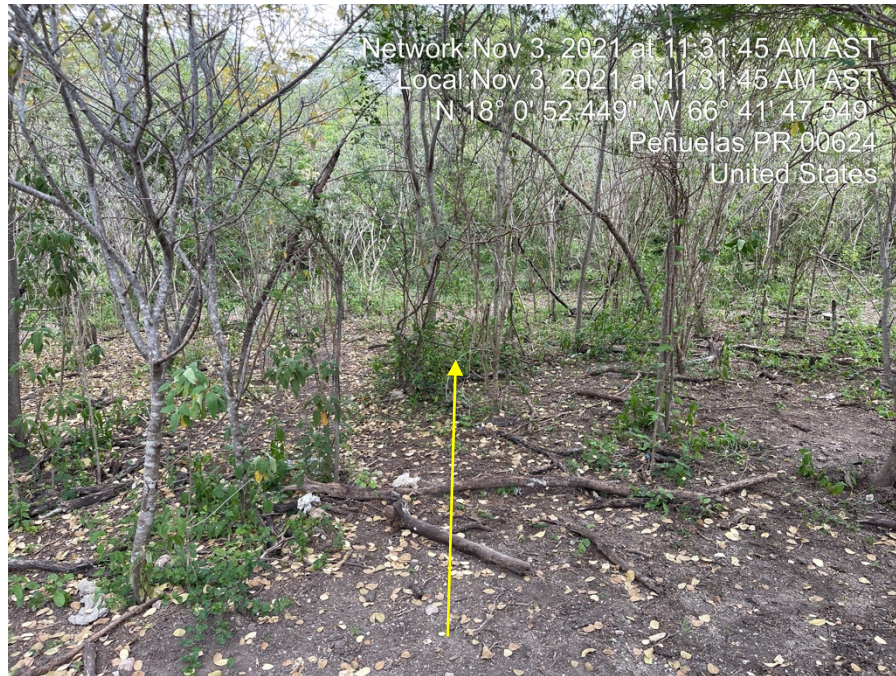
Picture 5 Another view of the existing ground conditions. The soil has been subject to intense use by grazing cattle.

Our team found several sections of the Site segregated with barbed wire. However, the wire conditions were mainly poor, allowing the cattle to roam freely around the premises. There is no defined access gate or trail to the Site. Our team entered through the center of the north side to conduct the site inspection, following the paths left by the animals. The existing conditions allowed the team to walk the entire Site clearing area following a zigzag pattern (west to east) of no more than 10 feet. There are dozens of dead trees scattered over the ground. Trees and plants observed are common to the ecosystems of the south coastal dry forest and represent the overgrown vacant land lots. The biological associations are common to upland systems.

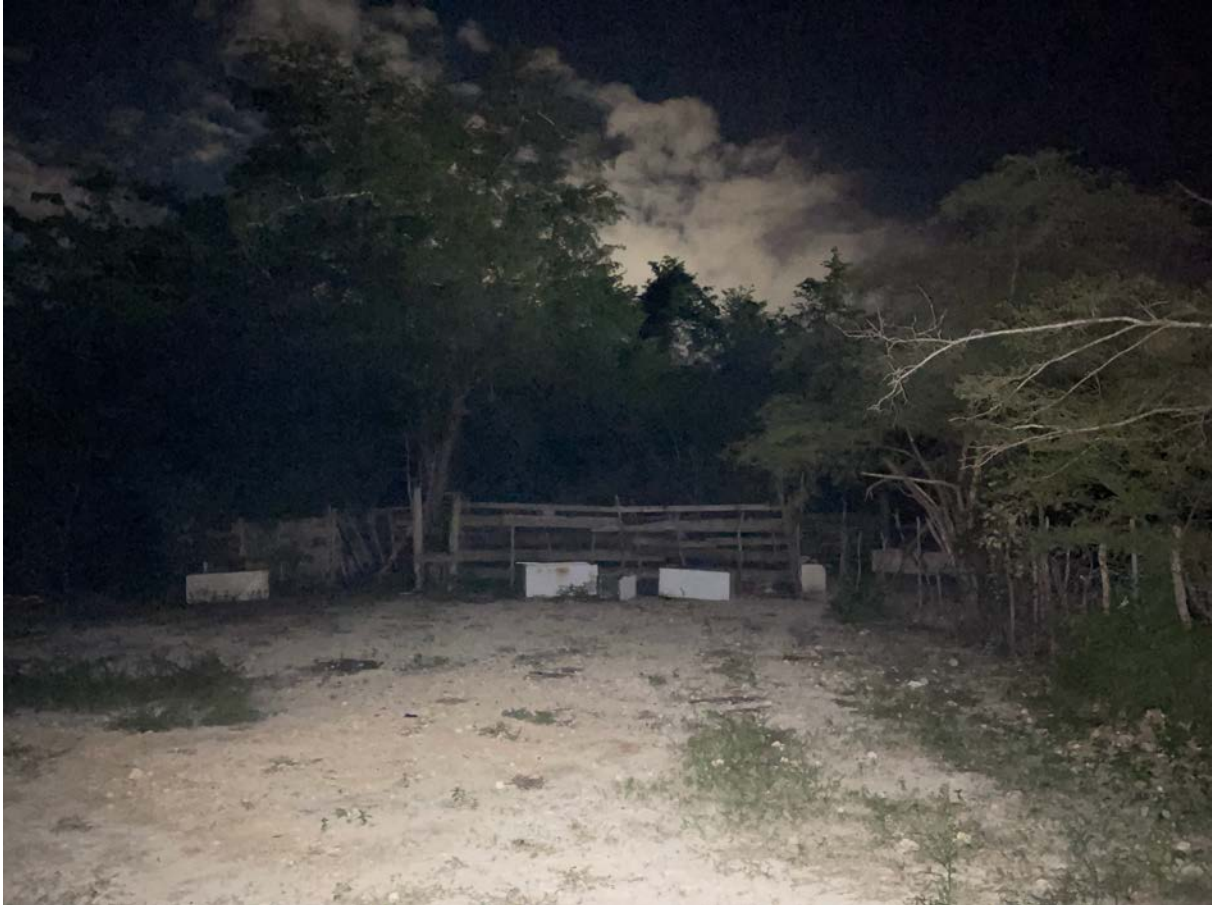
Picture 9 Area where cattle are fed.

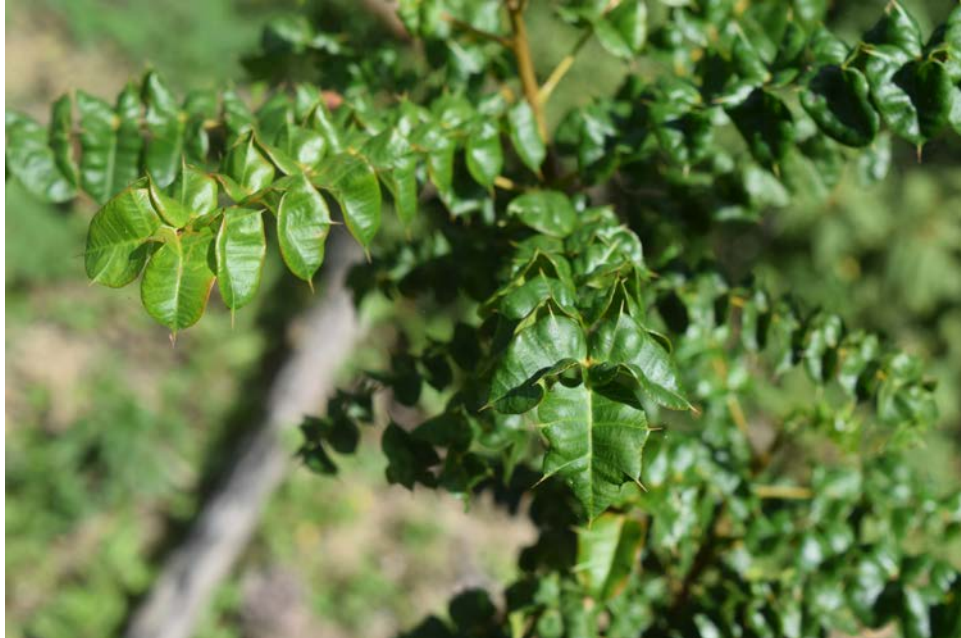
Picture 10: Close-up view of the Carrasco, another toxic and common species observed across the area.
